Re: Fluvial Geomorphic Assessment for Water Crossings to the Line 8 and Sideroad 10 Road Improvements in Bradford West Gwillimbury, ON

Fluvial Geomorphic Assessment

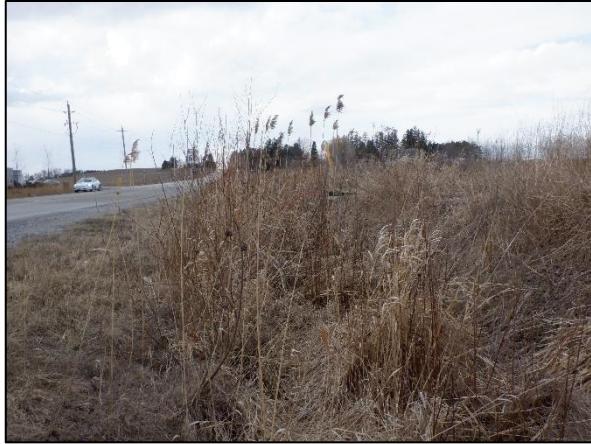
The crossings will be referenced from west to east and from upstream to downstream as indicated in Figure 1. Crossing 1 (Figure 1) is fed by a headwater drainage feature that crosses agricultural field and drains to a grass-lined roadside ditch (Figure 2). The ditch spans 3 meters at bankfull and narrows to less than 0.5 m at the base of the ditch. There is sparse phragmites in the ditch which will eventually proliferate and fill the ditch. At the northwest corner of Line 8 and 10

Figure 2: Grass-lined ditch upstream of Crossing 1

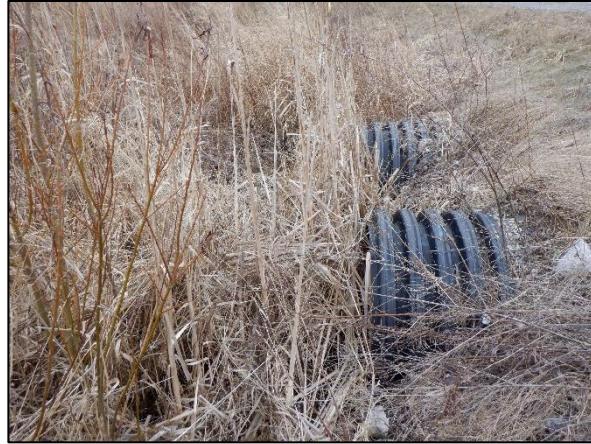
Sideroad there are 800 mm twin HDPE culverts that cross south to the southwest corner (Figure 3). Flow through this crossing is to the south.

Figure 3: Dual HDPE culverts on the northwest corner of Line 8 and 10 Sideroad.

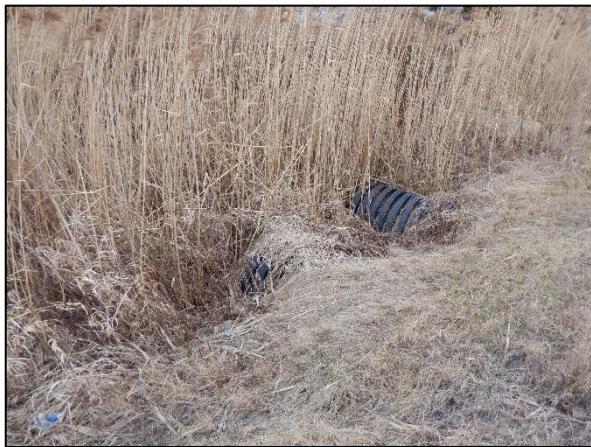
Phragmites has also filled the southwest corner of line 8 and 10 Sideroad where the twin HDPE culverts outlet to an open ditch (Figure 4) before crossing east across 10 Sideroad by a 350 mm culvert that was not located in the field (Figure 5). The channel on the southwest corner extends for approximately 30 m and form a 5 m to 6 m wide landscaped grassy swale. The swale is approximately 0.7 m deep and shows no indication of erosion.

Figure 4: Dual Culvert outlet into phragmites lined swale.

Design considerations to the preliminary channel design (Figure 14) should include hydraulic modelling of the proposed flows. Channel treatments shown in Figure 14 show proposed stone to be added to the ditch and swale on the northwest and southwest corners of the roundabout. Order of magnitude estimates of channel velocity suggest that flows will be in the range of 1 to 2.5 m/s and the channel banks and substrate should be designed appropriately. Channel design should incorporate natural channel design principals and be restored with native plantings where possible. Additionally, the phragmites in these channels should be treated and removed prior to channel restoration.

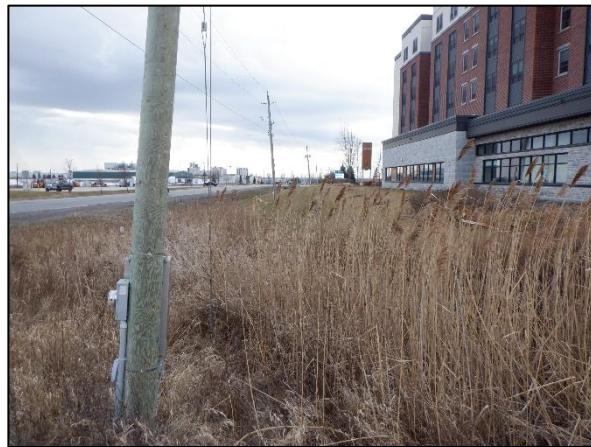
Figure 5: 5-6 m grassy swale on the southwest corner of Line 8 and 10 Sideroad.

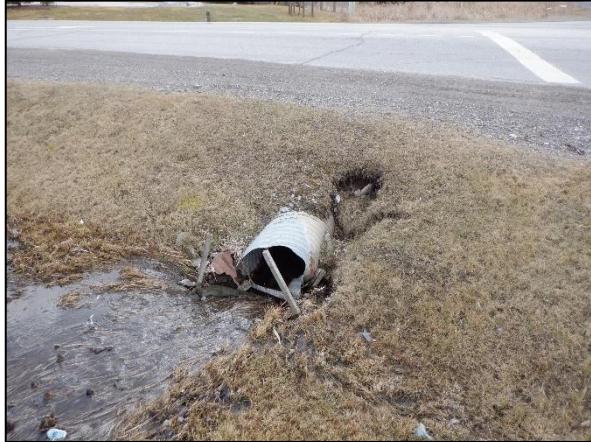
The northeast corner of Line 8 and 10 Sideroad has a 300 mm CSP culvert that outlets to the southeast corner. The road embankment shows sign of erosion from overland drainage and potentially elevated flow levels, indicating that the culvert is undersized (Figure 6). Flow through this crossing is to the south. The channel downstream of this culvert ranges from 2 to 5 m wide and has an average depth of 0.5m at bankfull. The channel is grass lined and at low flow becomes multi-threaded through a 100 m segment of channel, 50 m downstream of Line 8 (Figure 7).

Figure 6: Bank erosion on the northeast corner of Line 8 and 10 Sideroad.

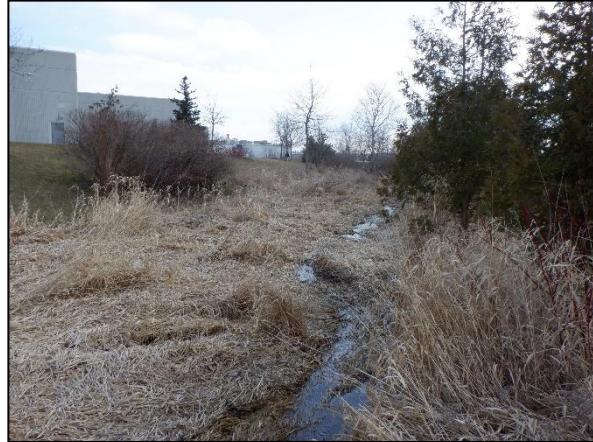
Figure 7: 2-5 m wide channel downstream of Line 8.

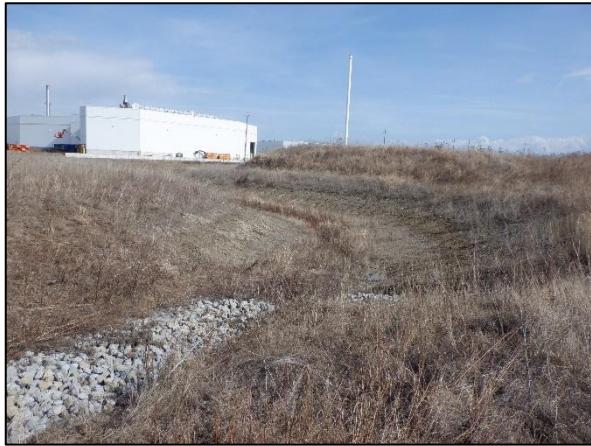
The channel transitions to a confined system as grading has been completed to accommodate the channel. This drainage pathway constitutes a rip rap lined intermittent channel that acts as an oversized headwater drainage feature (Figure 8).

Figure 8: Widened channel corridor is confined by graded berms close to Crossing 2 (Figure 1) at 10 Sideroad.

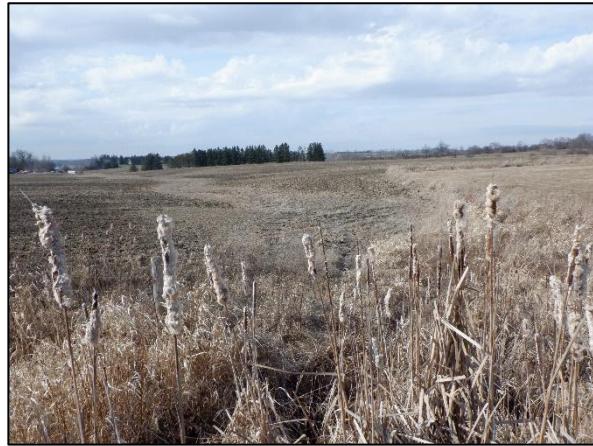
Figure 9: HDF west of Crossing 2 (Figure 1) 10 Sideroad.

As the channel crosses 10 Sideroad towards the west at Crossing 2 (Figure 1) it lacks a defined channel morphology and becomes a headwater drainage feature that crosses agricultural fields once more. There is no evidence of erosion apparent through this section or near 10 Sideroad. Throughout the reach the channel was poorly channelized, showed no significant erosion and was assessed to have little potential to meander.

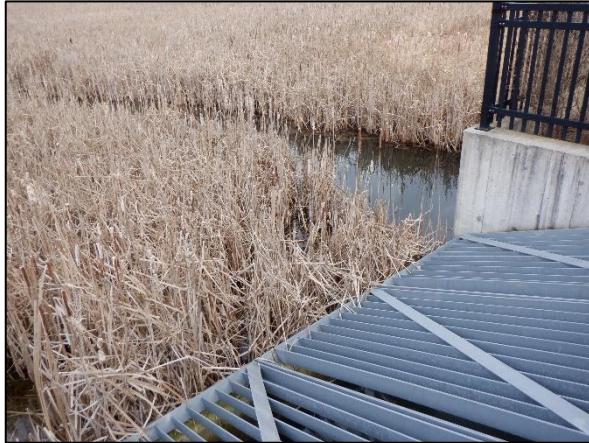
At Crossing 3 (Figure 1), the wetland/storm water facility shows multiple threads through the standing water. The flow passes over a weir structure built into a catch basin on the north side of Line 8 (Figure 10). Twin box culverts pass to the south under Line 8 and outlet to a wetland pond on the south side of the road. The wingwalls and road bed slope show no sign of outflanking or undermining, and there is little to no likelihood of this watercourse meandering.

Figure 10: Weir structure on the north side of Line 8.

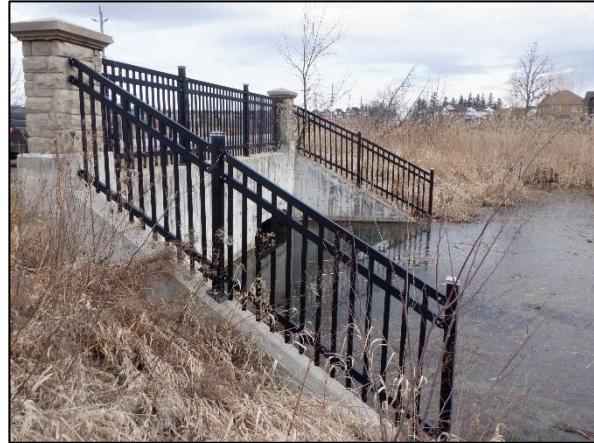
Figure 11: Twin concrete box culverts outlet to a wetland on the south side of Line 8 at Crossing 3 (Figure 1).

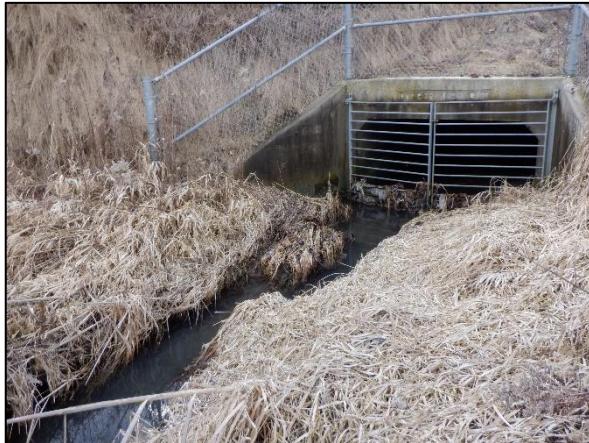
Crossing 4 (Figure 1) is outside of the study area and the affected road improvement in this study. The drainage flows along a pipe towards the north and outlets to the creek through a Box culvert (Figure 12). As the channel flows northeast away from the study area, the 5 m wide channel meanders close to the gabion lined slope along Line 8. Future road improvements to the east of this study area will need to assess the erosion hazard limit of this channel.

Figure 12: Box Culvert at Crossing 4 (Figure 1) on the North side of Line 8.

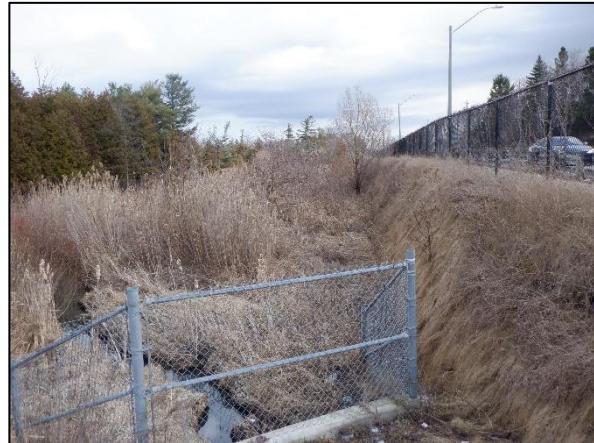
Figure 13: Meandering channel along Line 8, east of the study area.

Crossing 4 is completely piped and does not require a meander belt hazard delineation through the study area subject to road improvements. Downstream of crossing 4 would require a meander belt assessment for any future road improvements, as it is with close proximity to Line 8, but remains outside of the scope of the proposed work.
