LittaTraps

Town of Bradford West Gwillimbury

What are Litta Traps?

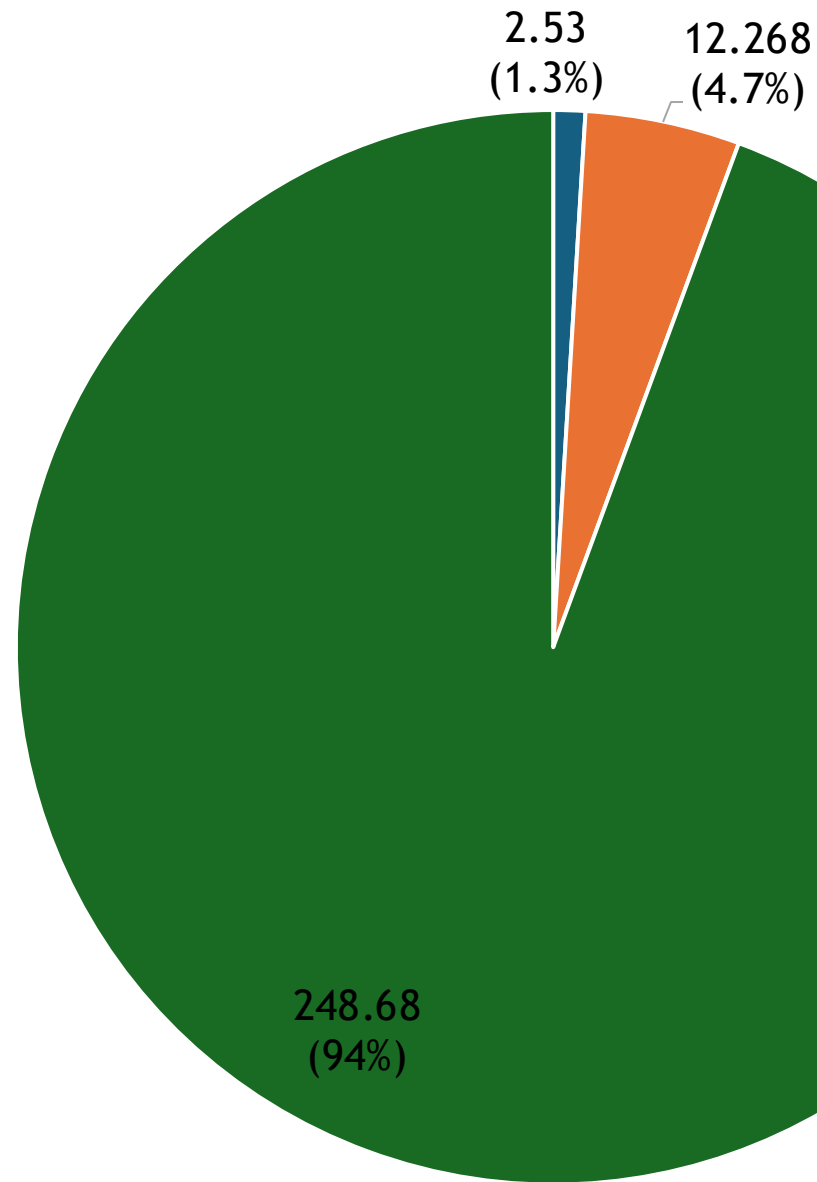
Figure 12: LittaTrap Waste Audit Summary (Fall)

- ▶ Total : 263.47 kg of Waste
- ▶ Sediment: 248.68 kg (94%)
- ▶ Organic Matter: 12.268 kg (4.7%)
- ▶ Plastics/Litter: 2.53 kg (1.3%)

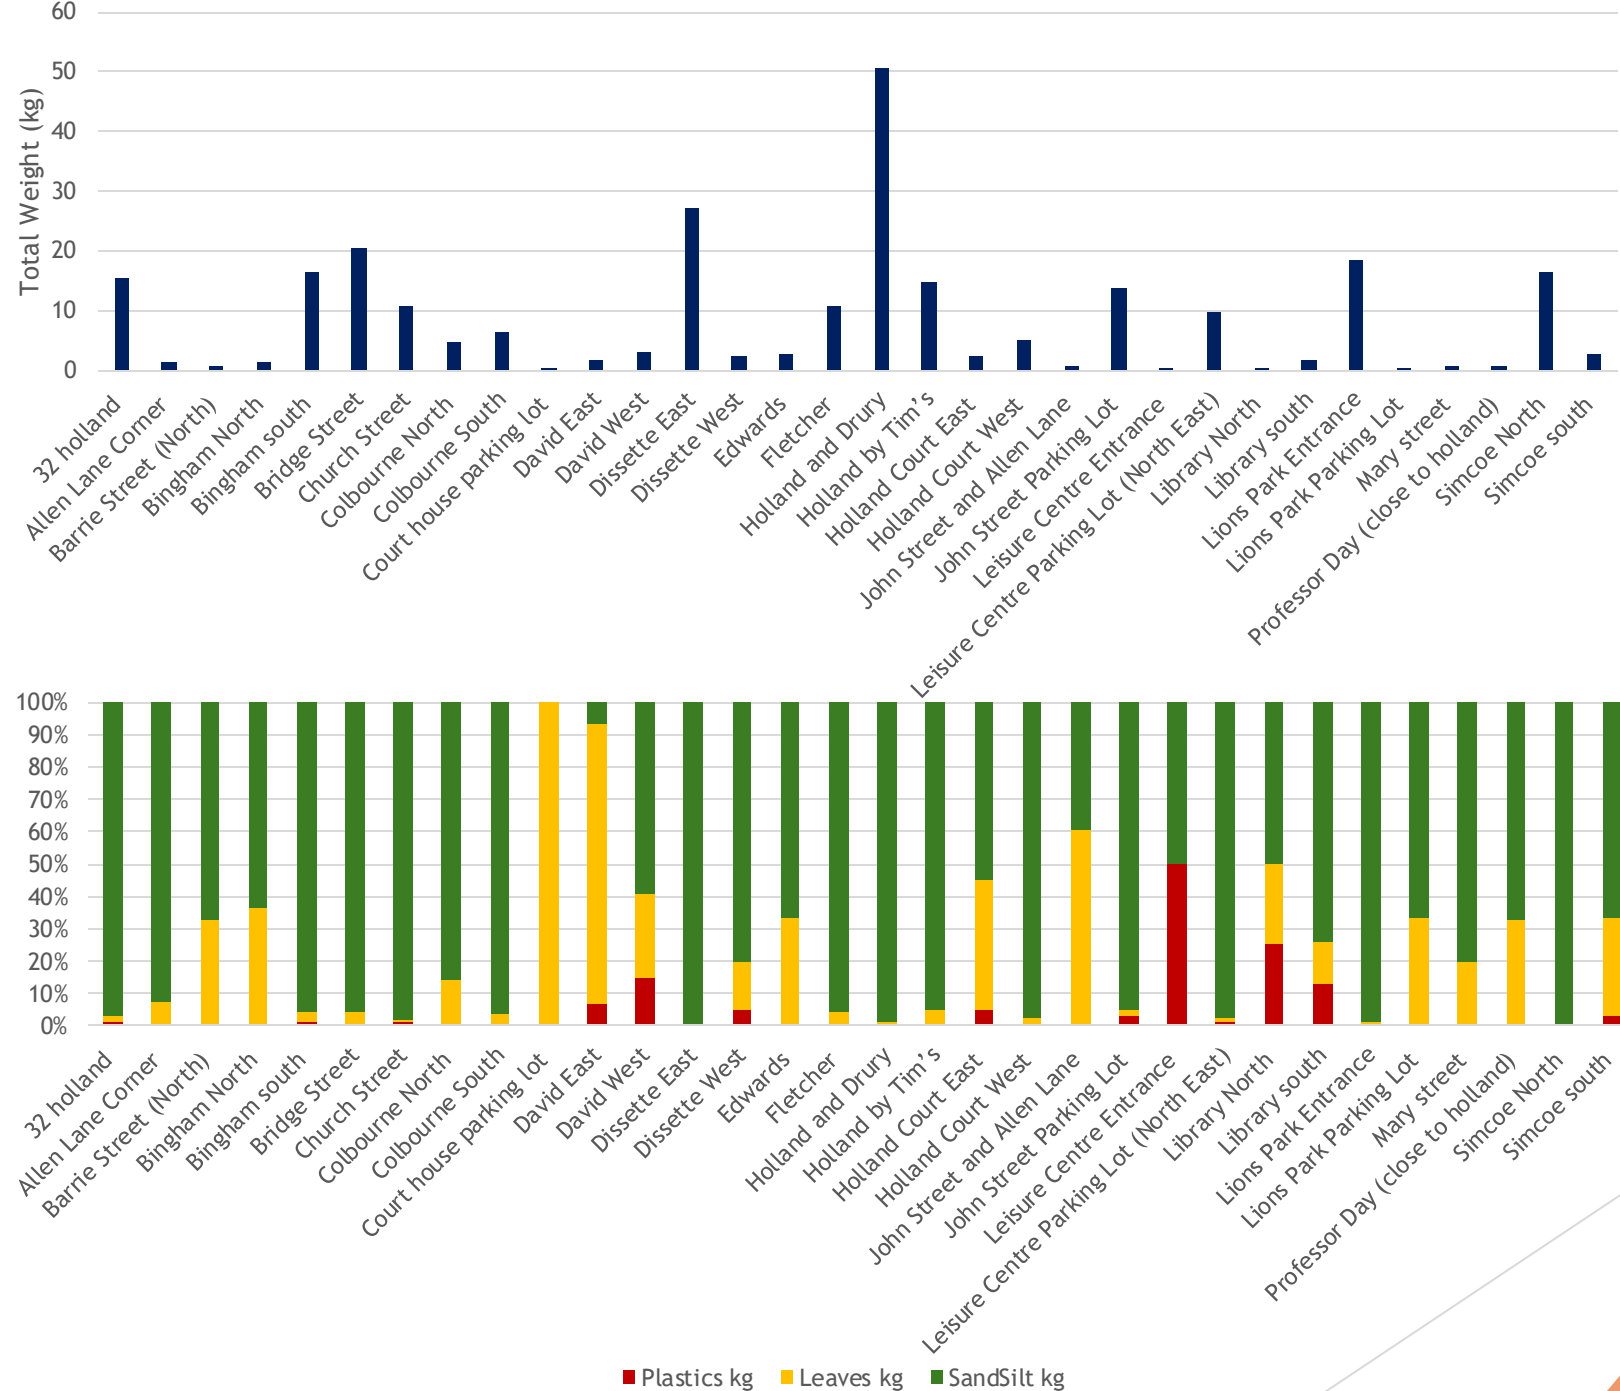
Figure 13: LitterTrap Waste Audit Data (Fall)

- Results categorized by **Location** and composition of **Plastics/Litter, Organics and Sand/Silt**
- Average Weight: 8.23 kg**

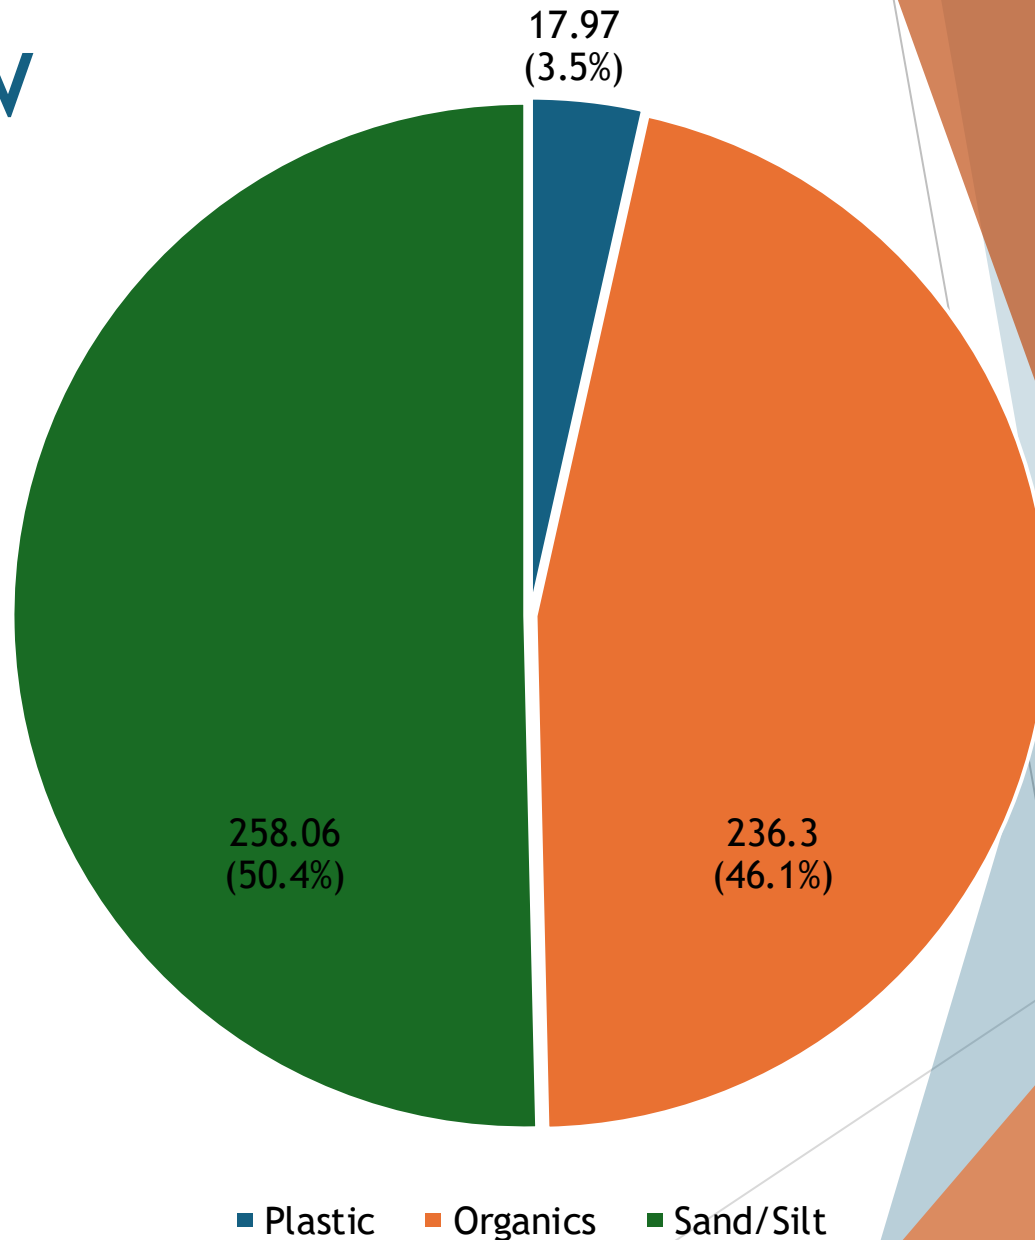
Figure 14: LittaTrap Waste Audit Summary (Spring)

- ▶ Total : 511.87 kg of Waste
- ▶ Sediment: 258.06 kg (50.4%)
- ▶ Organic Matter: 236.3 kg (46.1%)
- ▶ Plastics/Litter: 17.97 kg (3.5%)

- ▶ Waste contents vary significantly (different cleaning frequencies)
- ▶ Spring cleanout captures much more material (19x organics, 7x plastics/litter & almost 2x overall material)
- ▶ Litta Traps are very effective in sediment removal

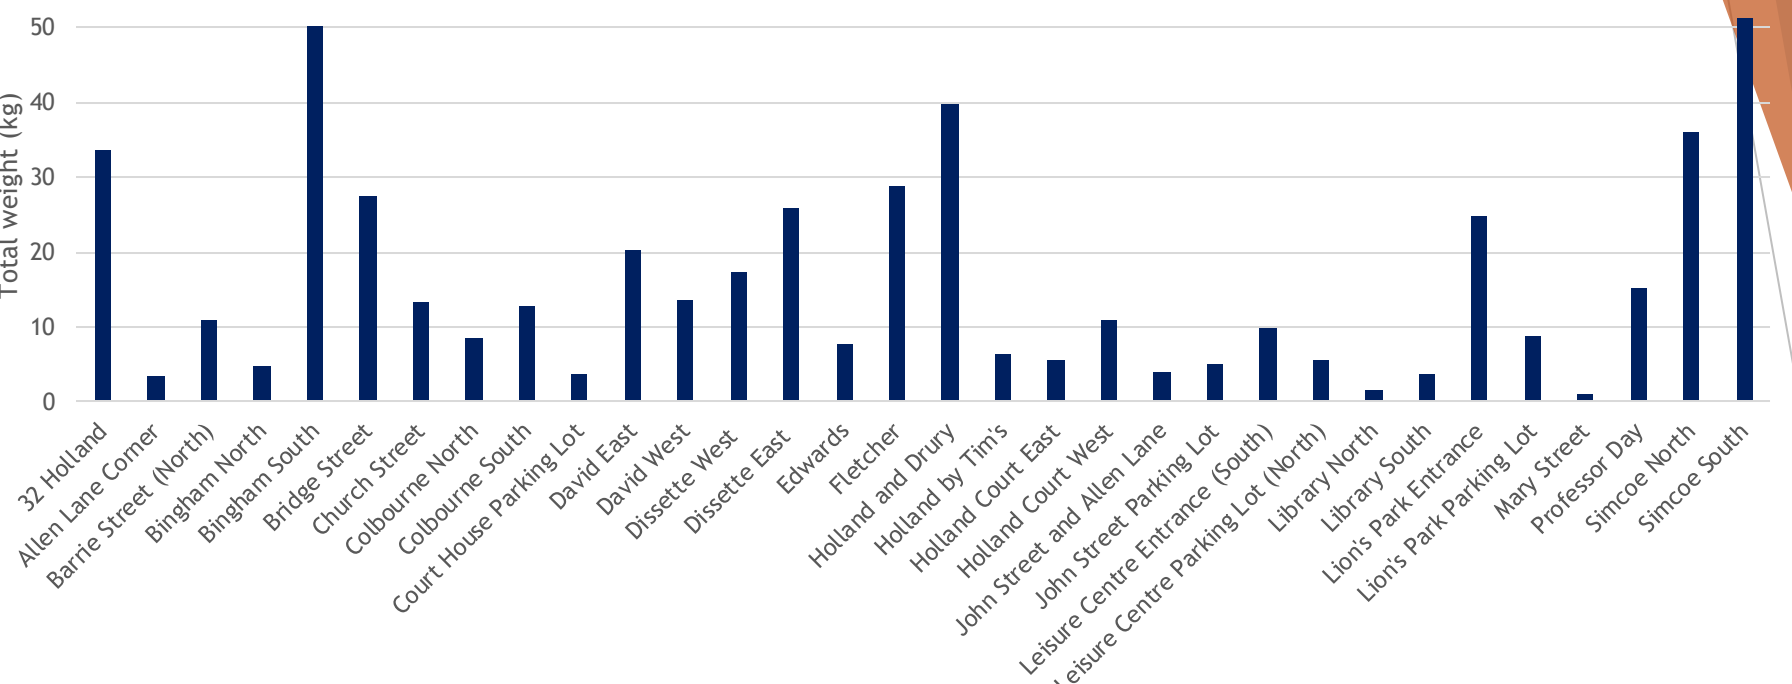
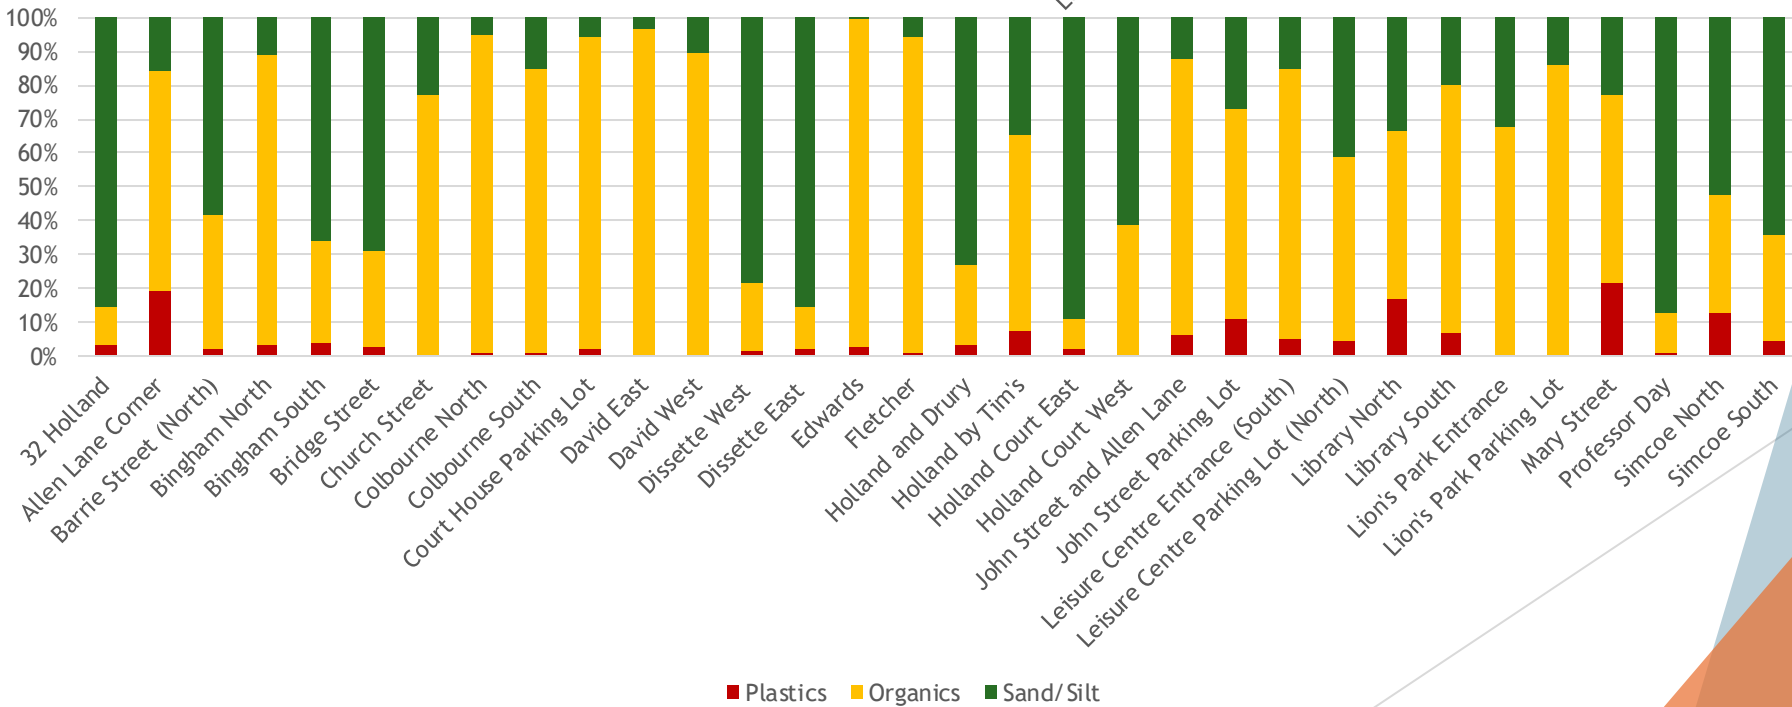
Figure 15: LittaTrap Waste Audit Data (Spring)

- **Average Weight: 15.99 kg**

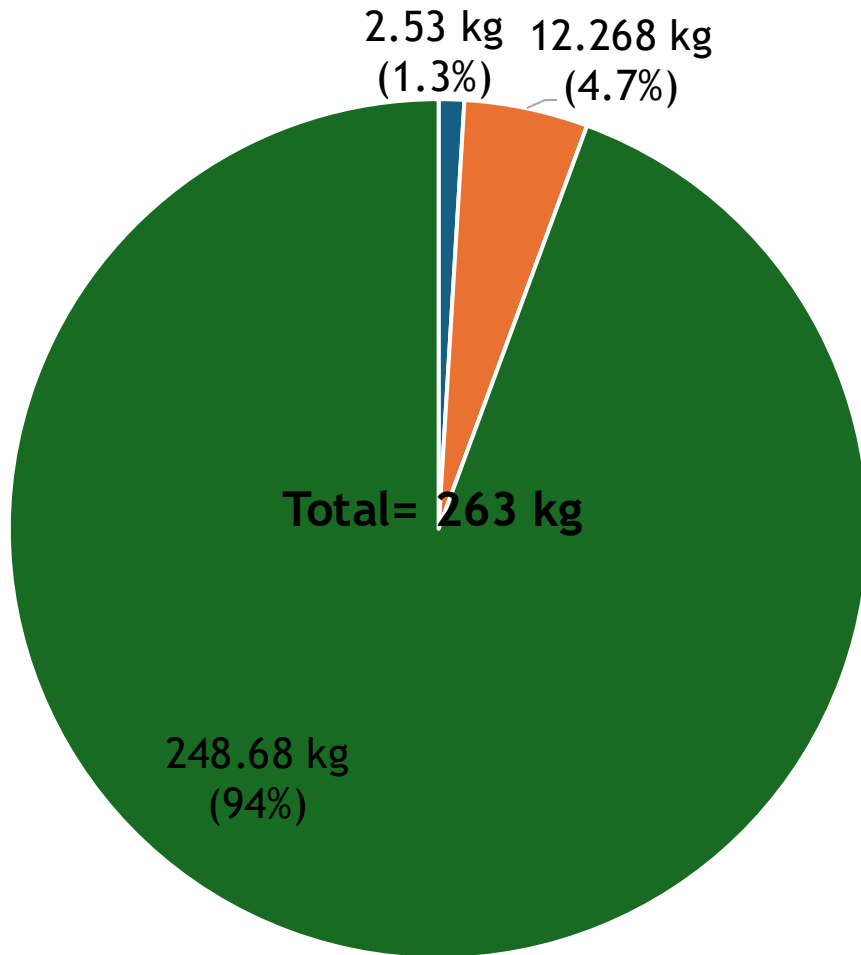
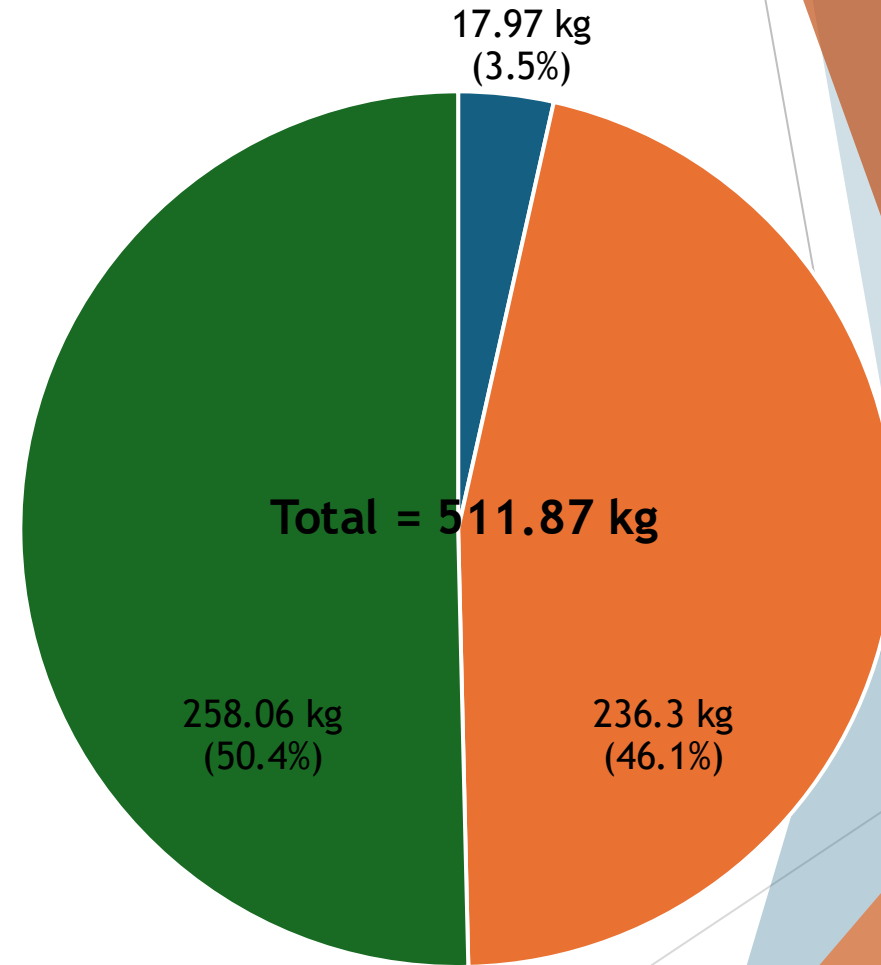
Figure 14: LittaTrap Waste Audit Summary (Fall)

Figure 15: LittaTrap Waste Audit Summary (Spring)
