NOISE IMPACT ASSESSMENT MEMO

Reference: Noise Impact Assessment Memo for Highway 400 Interchange at Simcoe County Road 88 Bradford, Ontario (GWP 2331-16-00)

The Ontario Ministry of Transportation (MTO) retained Stantec Consulting Ltd. (Stantec) to complete the Detail Design and Class Environmental Assessment (EA) for Highway 400 Improvements at the Simcoe Road 88 interchange, in the Town of Bradford West Gwillimbury, County of Simcoe (GWP 2331-16-00).

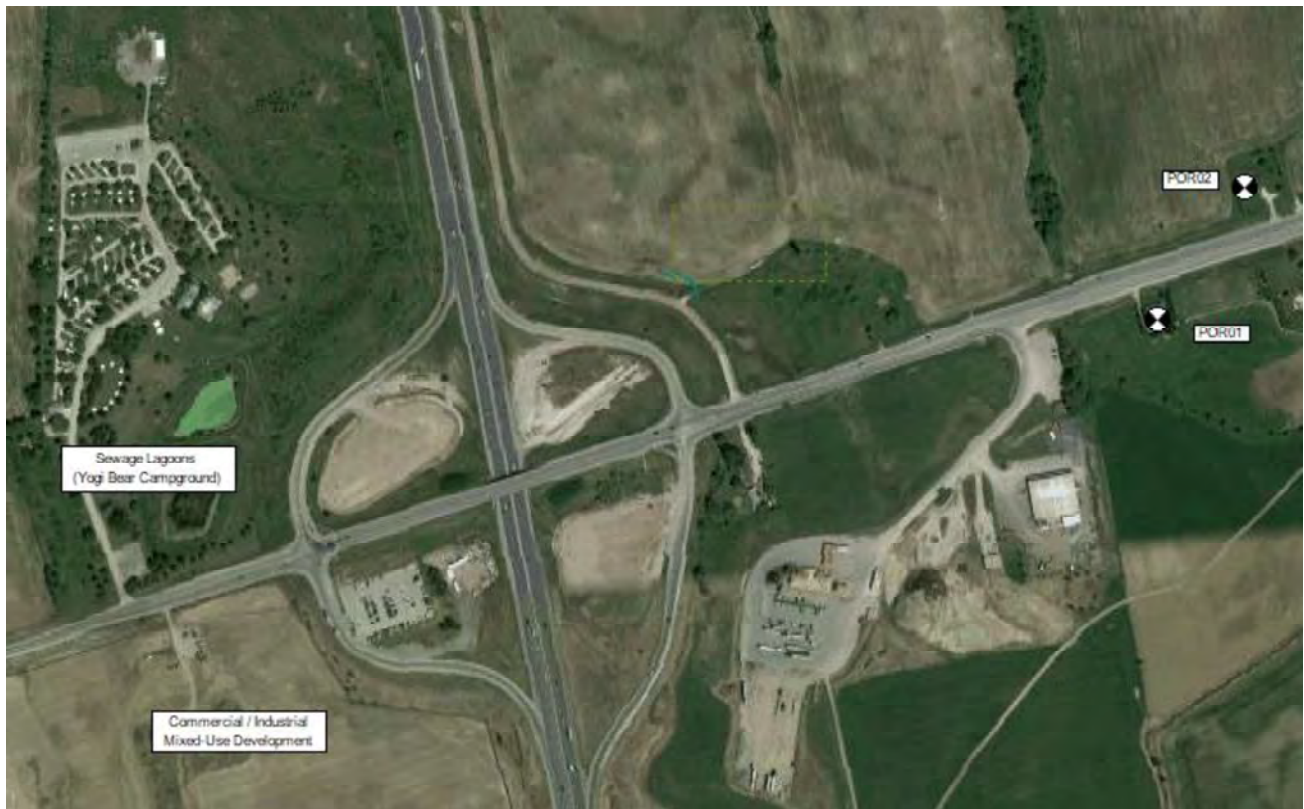
Figure 1: Receptor Locations

Sewage lagoons with clay lining are identified at Yogi Bear Campground (see Figure 1) and they are over 200 m away from the closest piling location for the bridge which is beyond the zone of influence for construction vibration for damage.

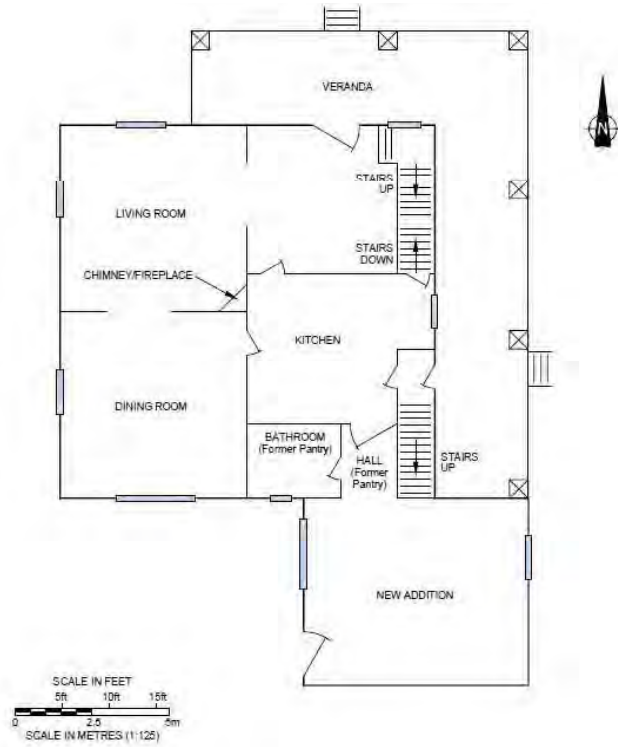
Plate 2: First Storey (Golder Associates 2011)

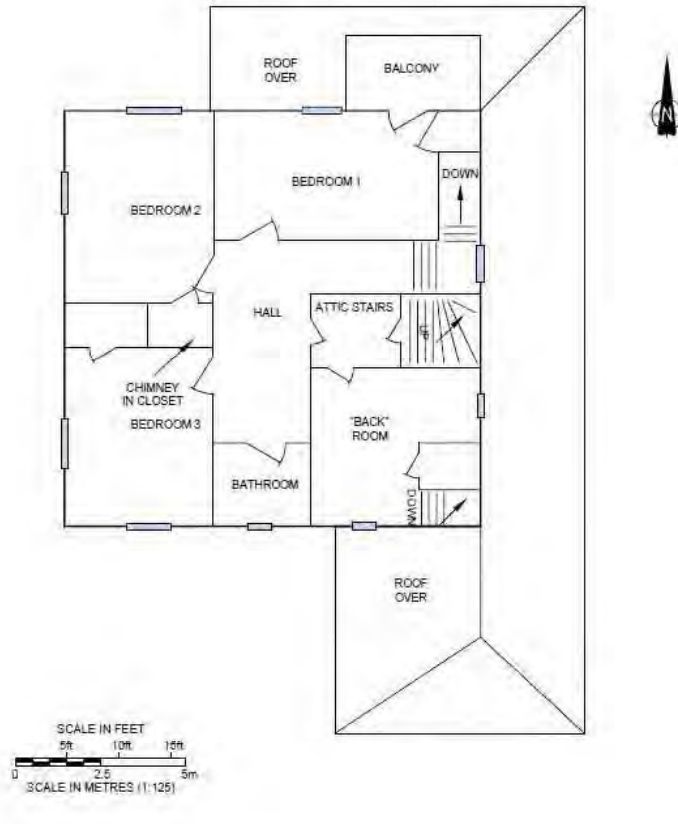
Plate 3: Second Storey (Golder Associates 2011)

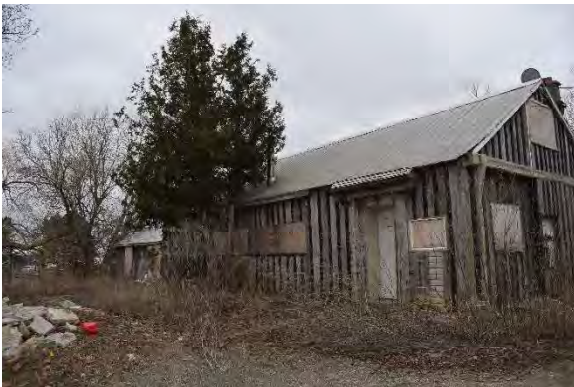
The second outbuilding is located southwest of the residence. This building contains a gable roof and shed roof clad in asphalt shingles. This outbuilding contains no foundation. The outbuilding is clad board and batten siding and plywood. The window openings and door openings have been boarded up (Photo 44).

Photo 44: East façade of outbuilding, looking west
