Re: Fluvial Geomorphic Assessment for Water Crossings to the Line 8 and Sideroad 10 Road Improvements in Bradford West Gwillimbury, ON

Fluvial Geomorphic Assessment

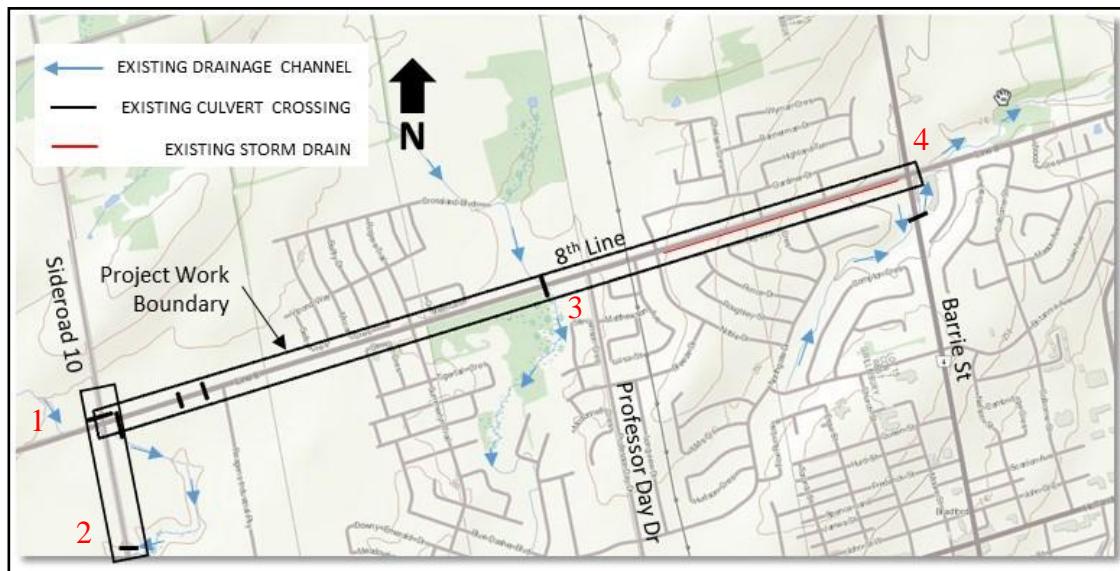
Figure 1: Drainage channels that cross Line 8 and Sideroad 10 with numbered crossings (red)

The crossings will be referenced from west to east and from upstream to downstream as indicated in Figure 1. Crossing 1 (Figure 1) is fed by a headwater drainage feature that crosses agricultural field and drains to a grass-lined roadside ditch (Figure 2). The ditch spans 3 meters at bankfull and narrows to less than 0.5 m at the base of the ditch. There is sparse phragmites in the ditch which will eventually proliferate and fill the ditch. At the northwest corner of Line 8 and 10
